June 28, 2019
File No. 262018.063

Subject: Department of Natural Resources Washington Geological Survey,
School Seismic Safety Assessment Project, Contract No. AE 410 -
Seismic Evaluation for **Spokane School District**

School Buildings Evaluated in the Spokane School District

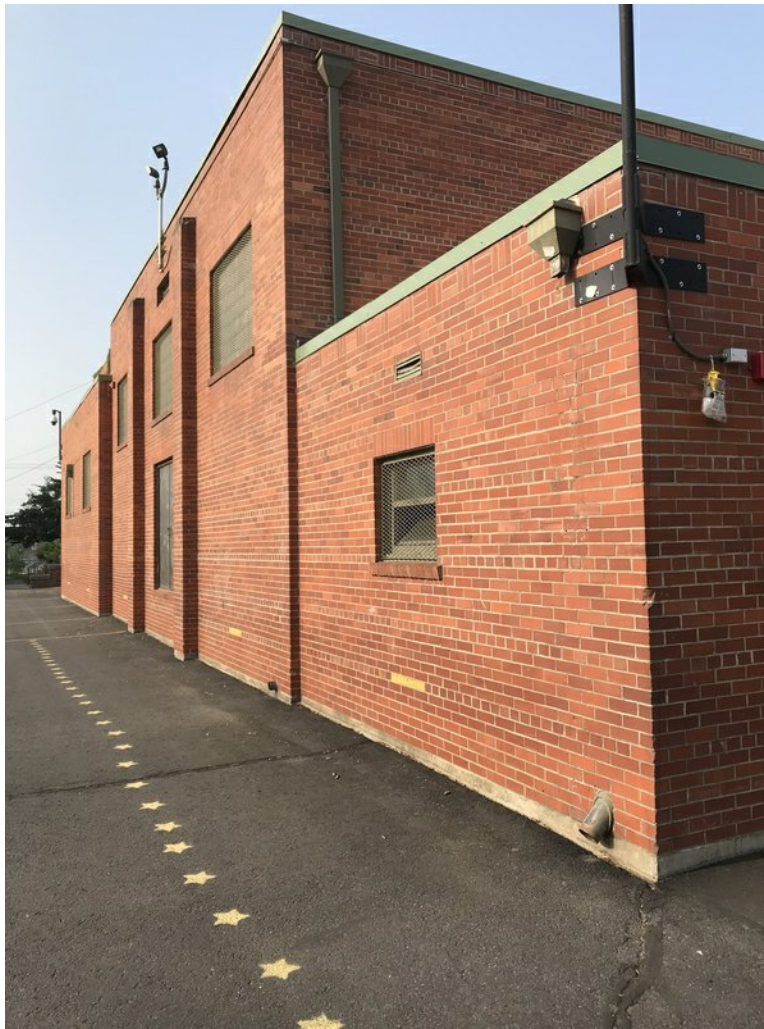
Figure 1-5. View from northeast corner of building with exterior pilasters visible at high roof area over the stage.

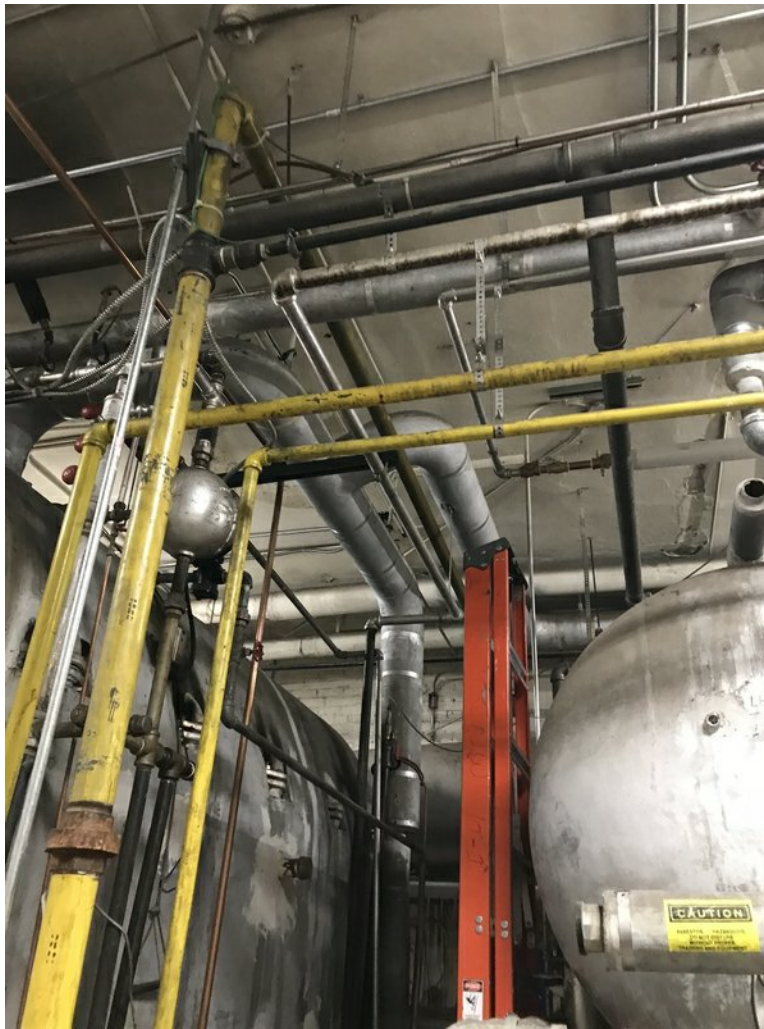
Figure 1-2. Mech Room - gas piping is painted yellow

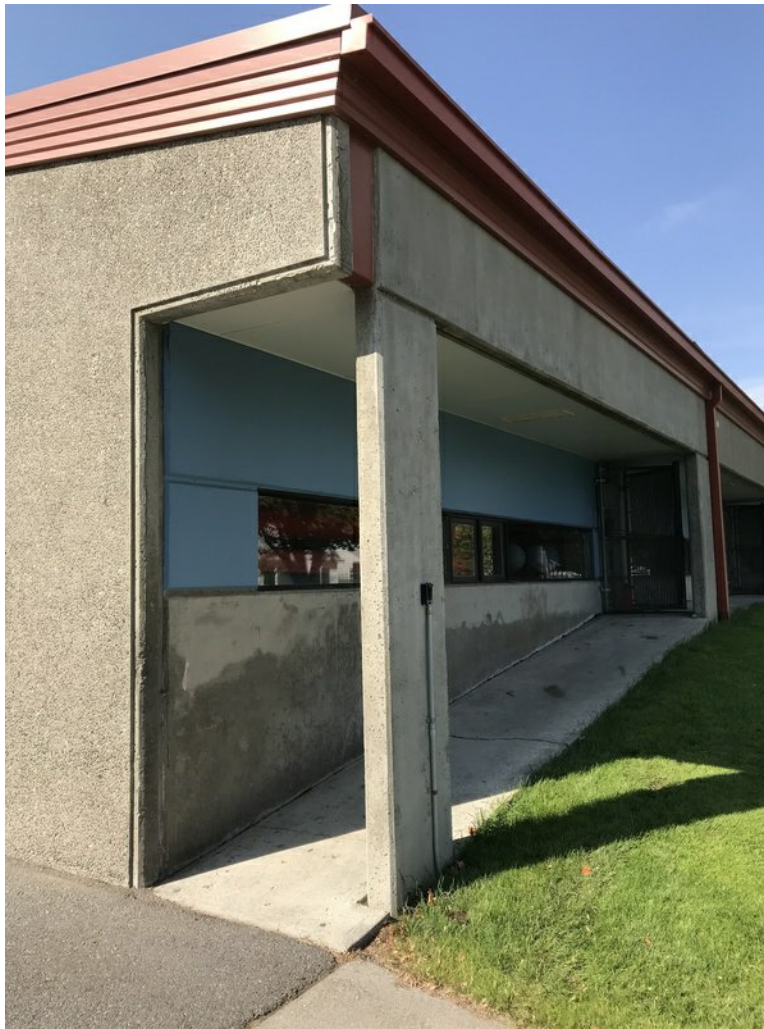
Figure 1-2. Precast frames and exterior walls at perimeter of classrooms. One of these elements is assumed to be the lateral system at the exterior walls.

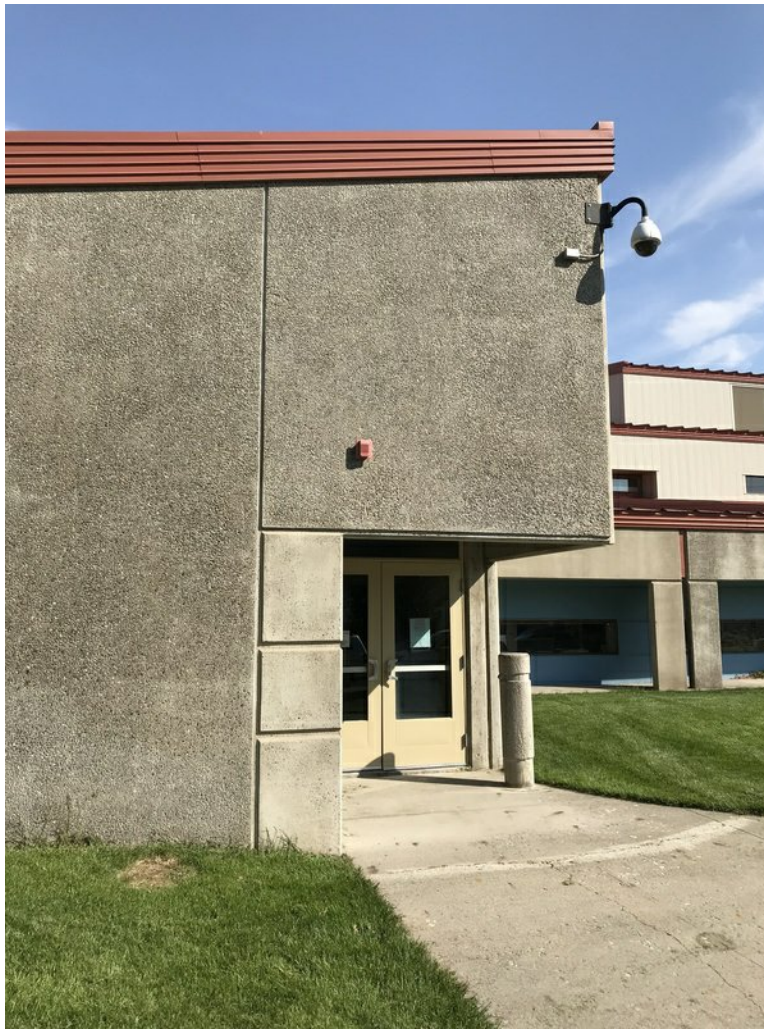
Figure 1-3. Concrete overhang at southwest entrance. Precast frames can be seen in the background.

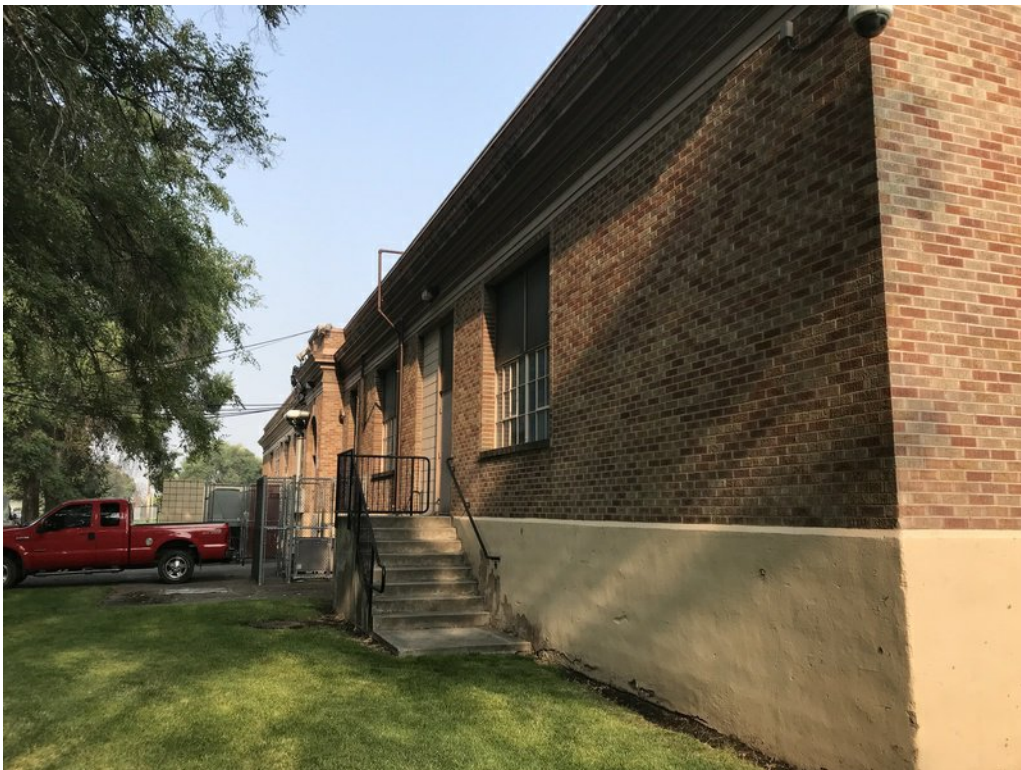
Figure 1-7. East face of center wing. Addition of an unknown date.

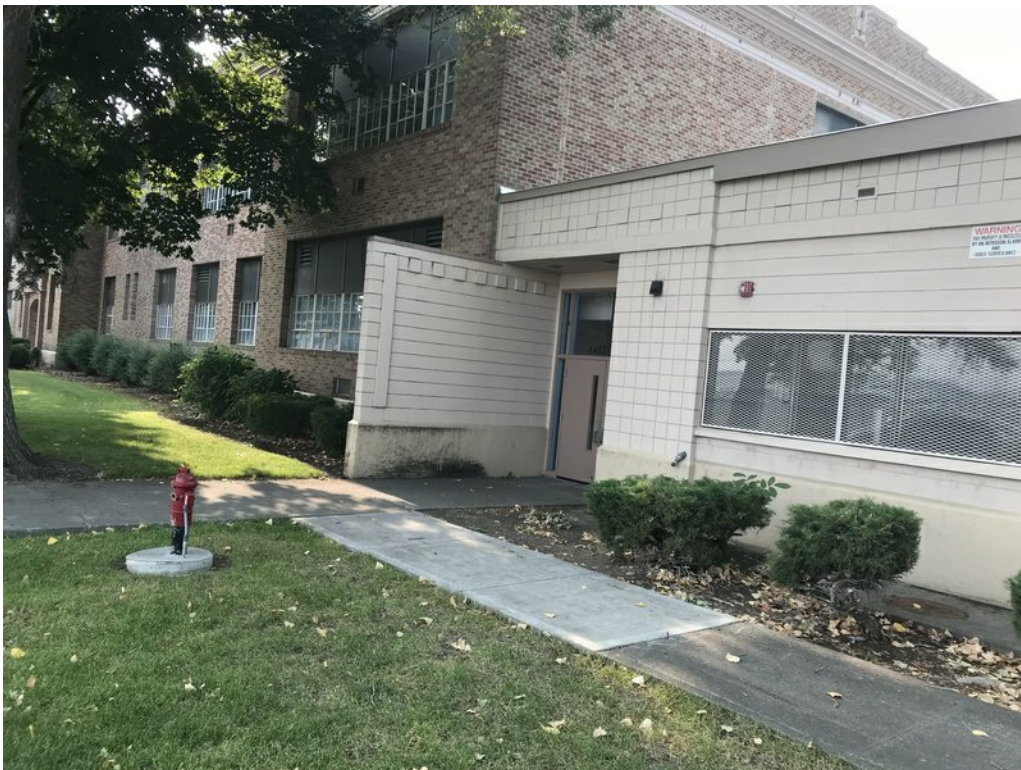
Figure 1-9. Southwest corner of central wing.
